Project
focus:
Stone and
concrete
repairs

Snapethorpe concrete repairs:

Concrete repairs in Preston:

Halifax Stone Repair:

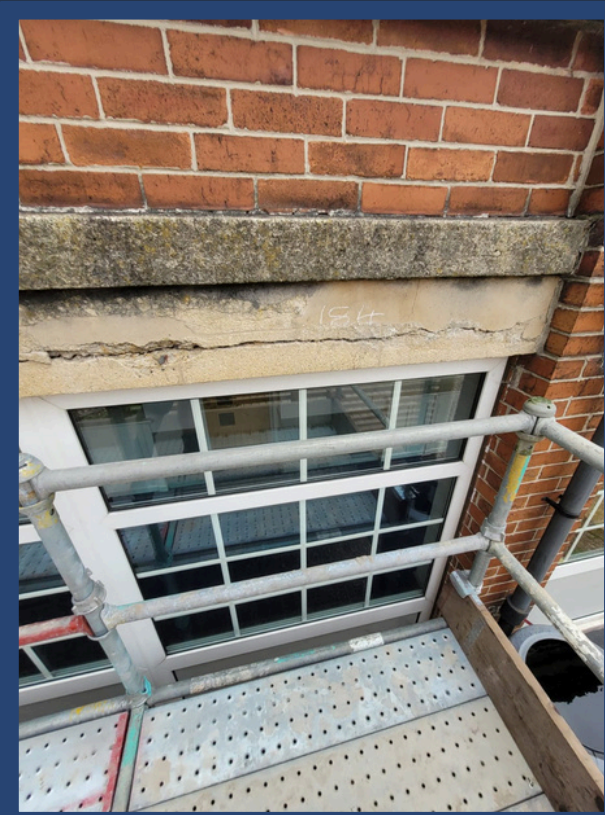
Before

The steel reinforcement bars within the sills and lintels had corroded over time, leading to the expansion and cracking of the surrounding concrete. To restore the structure, we carefully removed the damaged concrete, treated the exposed steel by cleaning and applying an anti-corrosion coating, and then rebuilt the concrete to match the original profile.

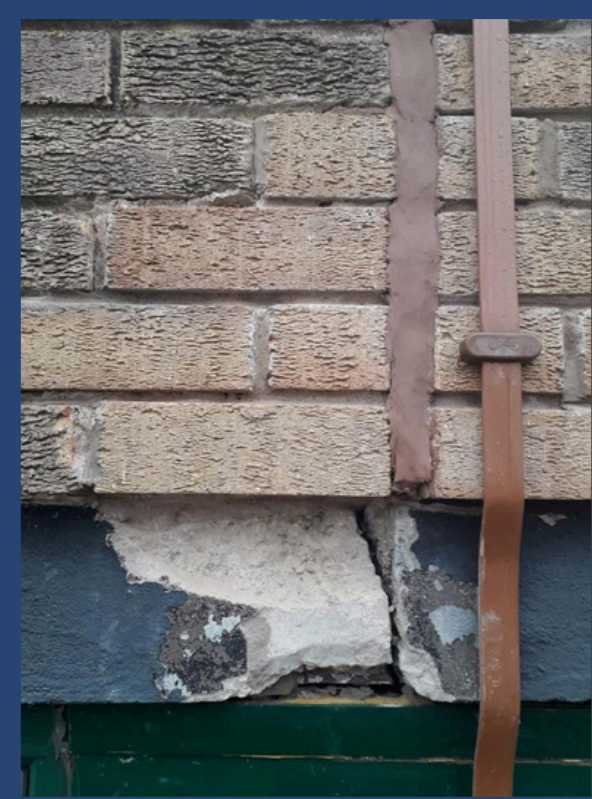
Before

This project involved cutting back eroded concrete to a sound surface and mechanically cleaning an exposed section of rebar.

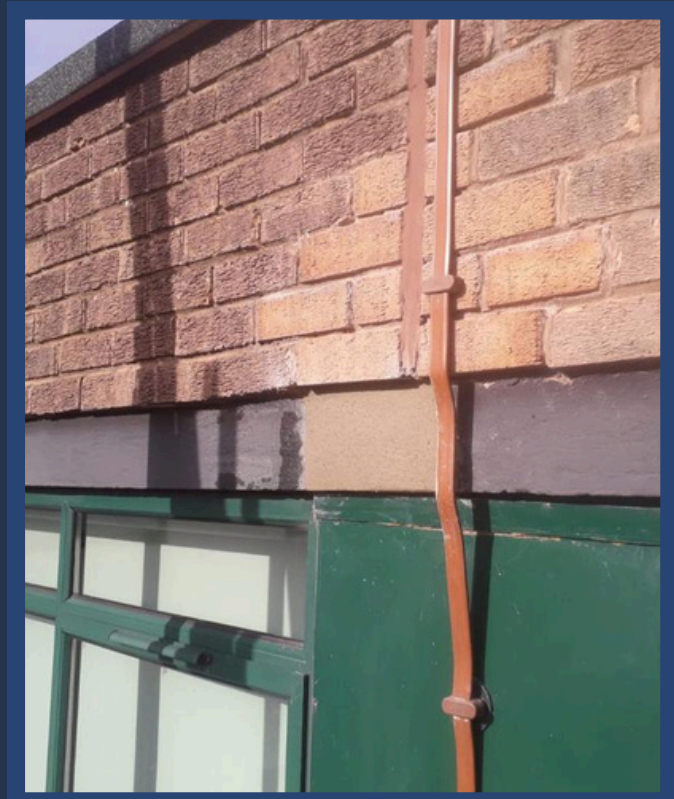
During

As the concrete was structurally integral – supporting the brickwork above – the removal process had to be carried out with great precision and care

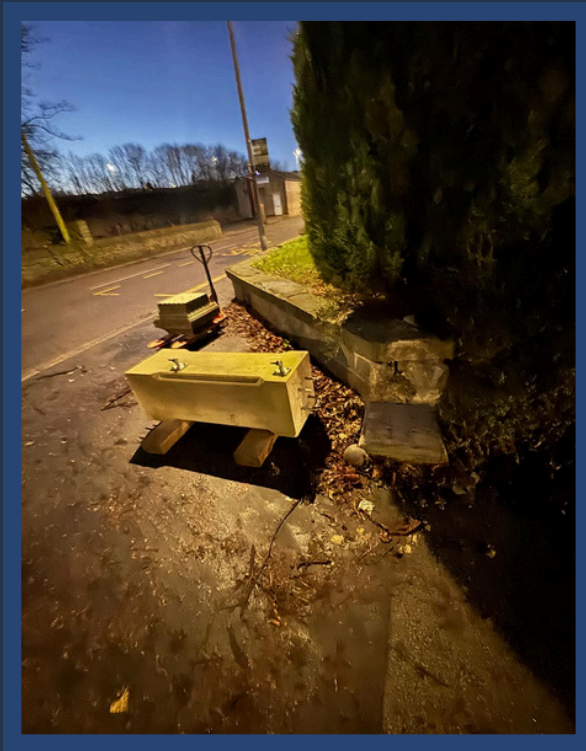
Before

Our team responded quickly to a local organisation after a vehicle damaged a pillar, posing a safety risk.
